Re: Meridian Automotive Systems Site  
Jackson, Jackson County, Ohio  
Technical Direction Document No.: S05-0001-1001-001  
Work Order No.: 20405.012.001.0902.00  
Document Control No.: 902-2A-AHFN

This letter report discusses the Site description, Site background, waste removal activities, disposal activities, and resources committed to the removal action. In addition, this letter report includes six attachments. Attachment A provides the figures for this letter report, Attachment B provides photographic documentation of Site conditions and removal activities, Attachment C summarizes the analytical results from the ERRS-procured laboratory, Attachment D summarizes the results of HAZCAT analysis, and Attachment E provides copies of the waste manifests.

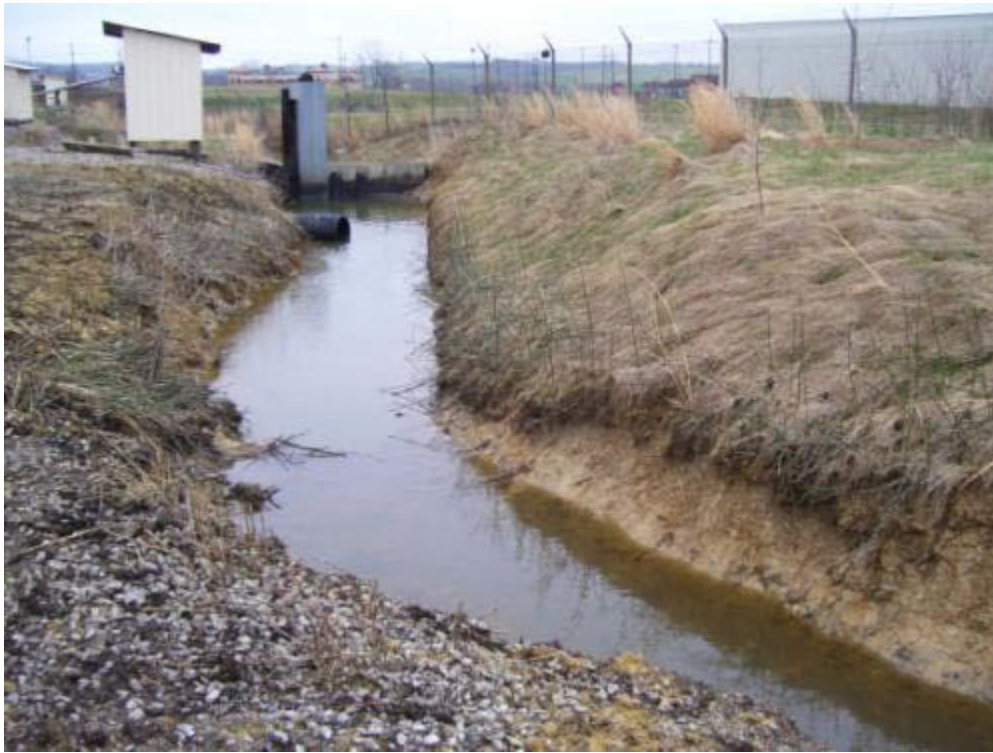
**Photograph No.:** 81

**Subject:** The storm water treatment ditch 6 weeks after the removal of sediment and soil
